AERIAL PHOTOGRAPHIC ANALYSIS OF SELECTED HAZARDOUS WASTE STUDY SITES

New Mexico and Texas

EPA Region VI

TS-AMD-82110a
April 1983

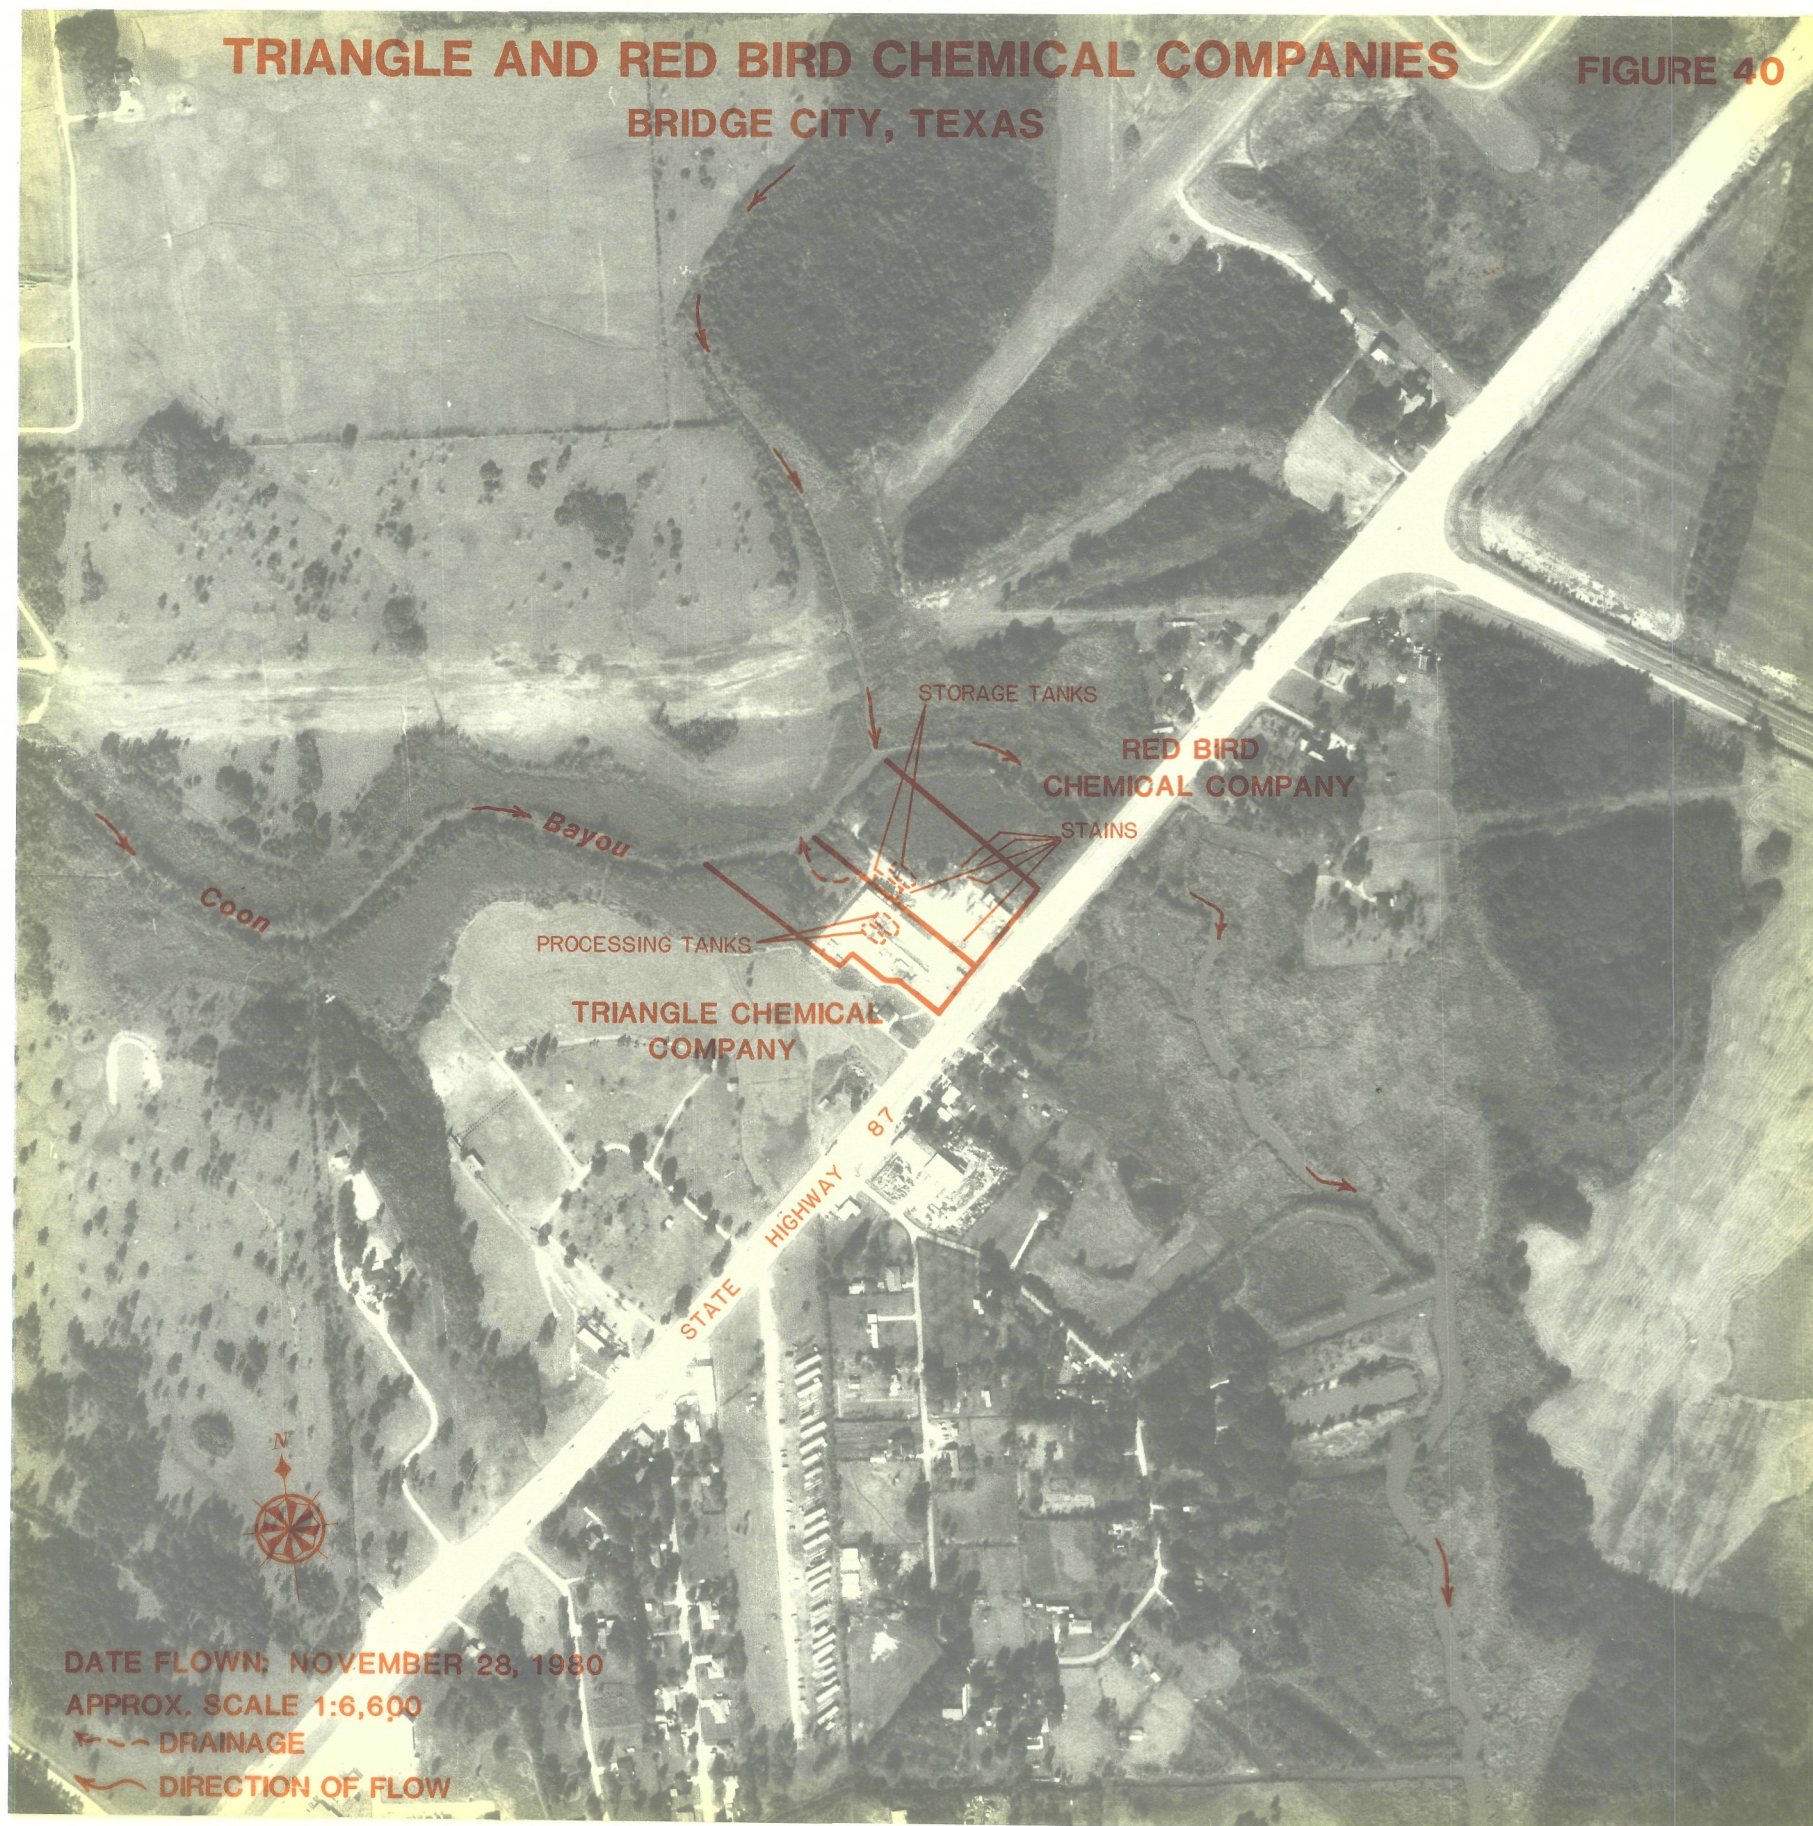
FIGURE 40

The Triangle Chemical and Red Bird Chemical Companies (Figure 40) appear structurally similar to their appearance on the December 1978 photograph. The concentration of drums that was present on December 16, 1978 (Figure 39), has been removed from the Red Bird facility. A large stain is visible in the general area where the drums were formerly situated. Additional stains are noted elsewhere within the Red Bird facility. There is no indication that spillage has flowed off the site.

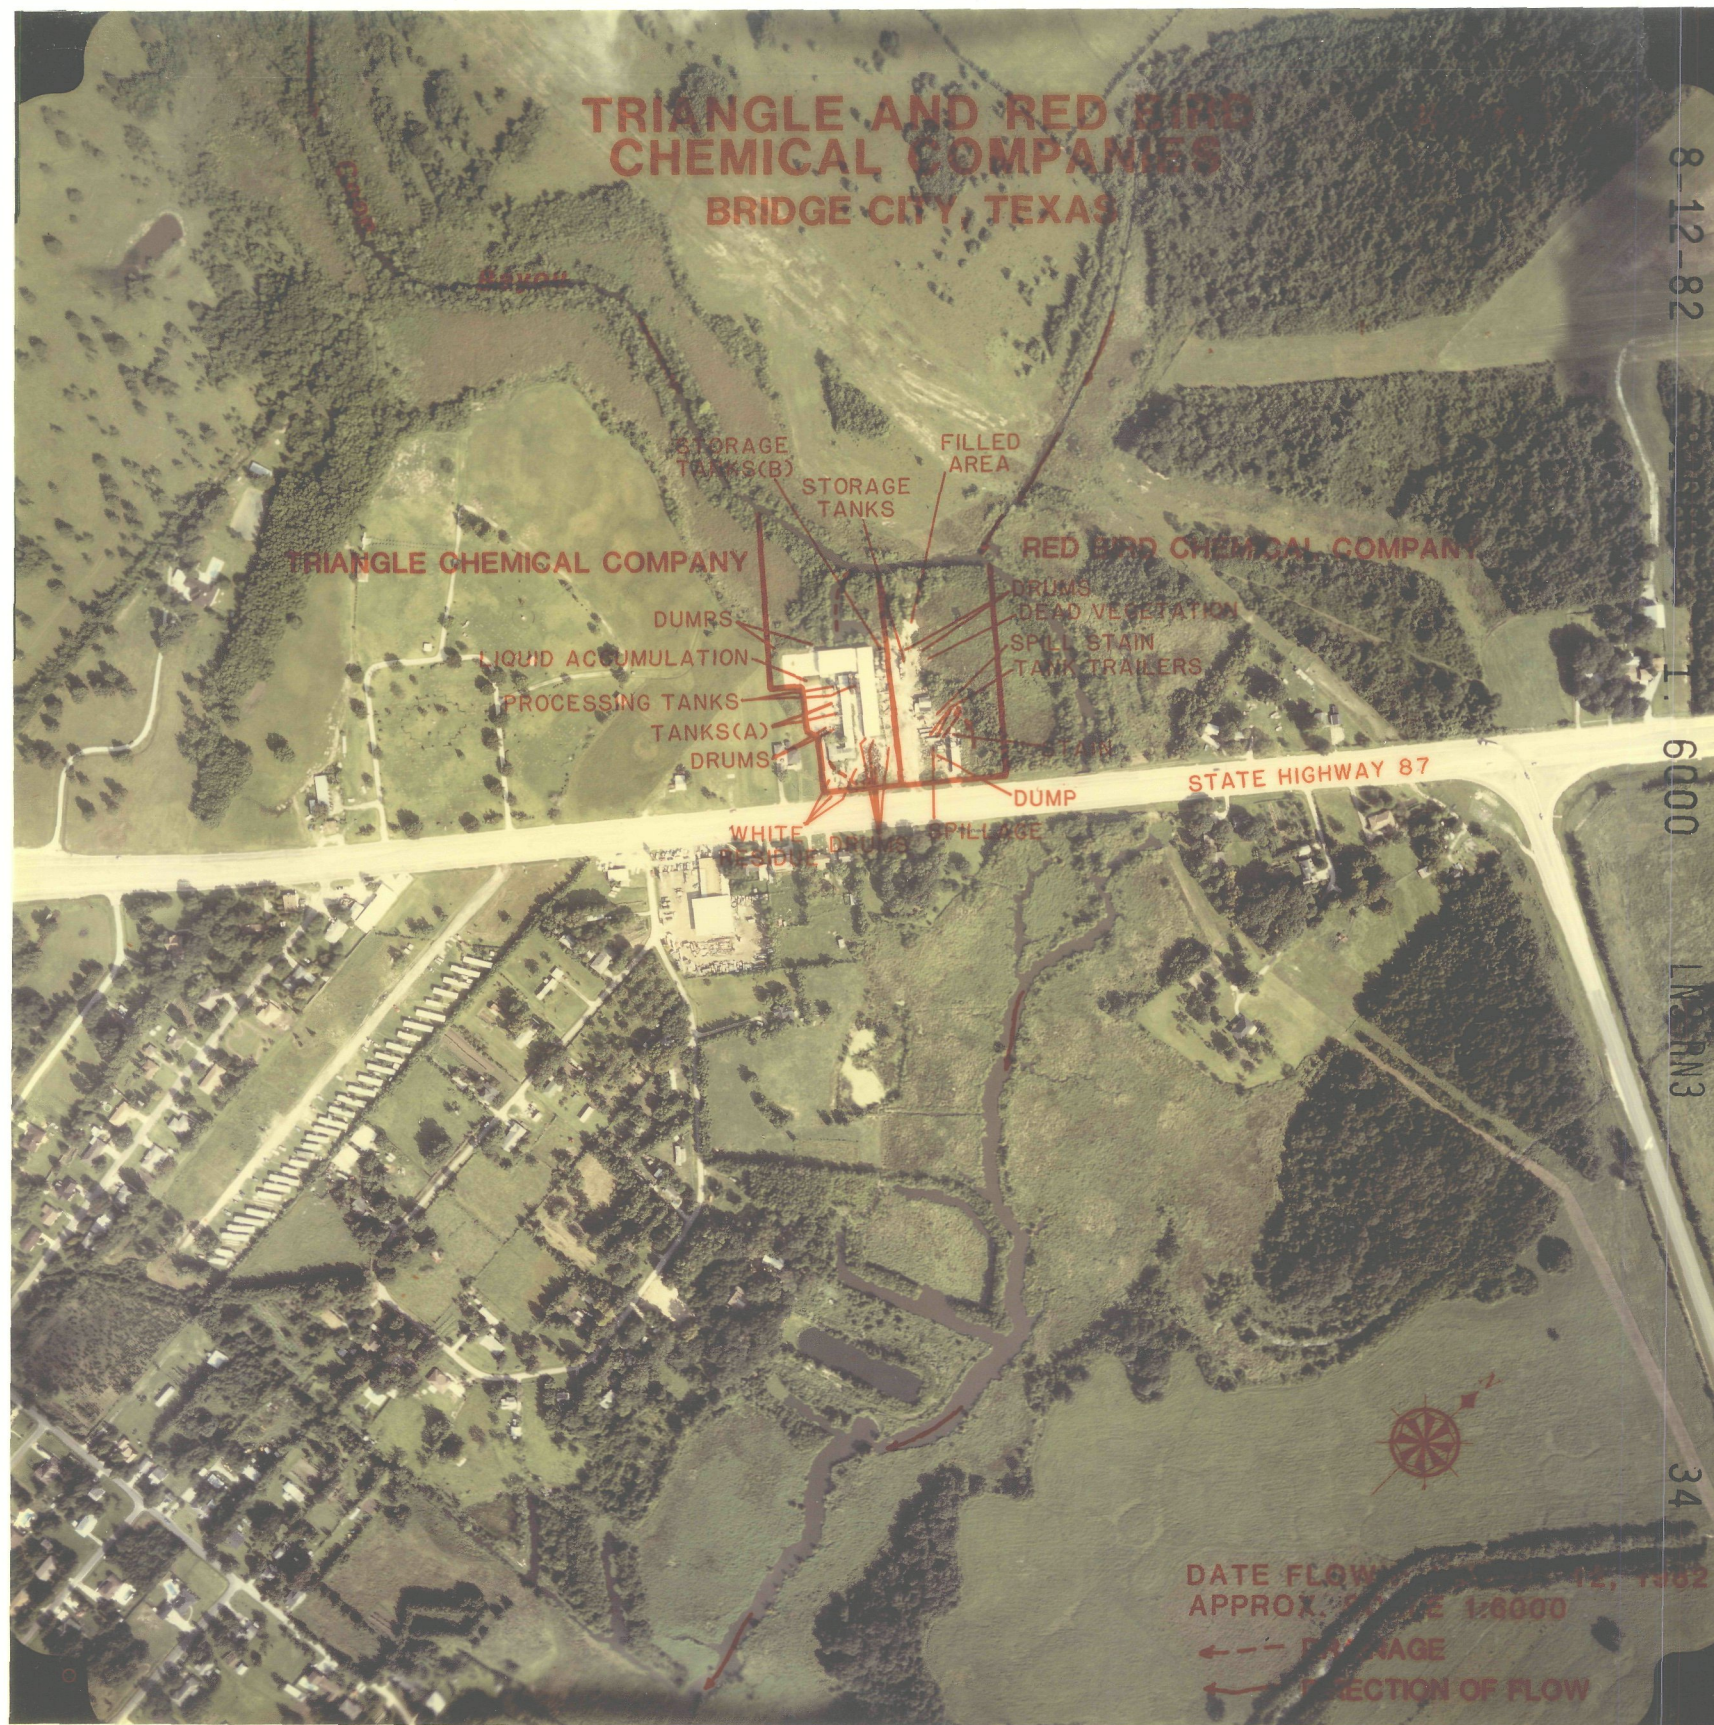
Approximately 400 drums have been deposited within the Triangle and Red Bird Chemical facilities subsequent to November 1980 (Figure 41). A white residue is visible near a concentration of drums that are located in the southeast corner of the Triangle Chemical Facility. A small amount of the same substance is noted upon State Highway 87. Two piles of rubble have been dumped in the northern portion of the site.

Spillage is visible within the Red Bird facility and appears to have drained northwestward into a site depression. Spill stains and dead vegetation are also noted. Some filling has taken place within the site. Brown areas noted within vegetation that abuts both the Red Bird and Triangle Chemical Companies appear to be waterlogged.

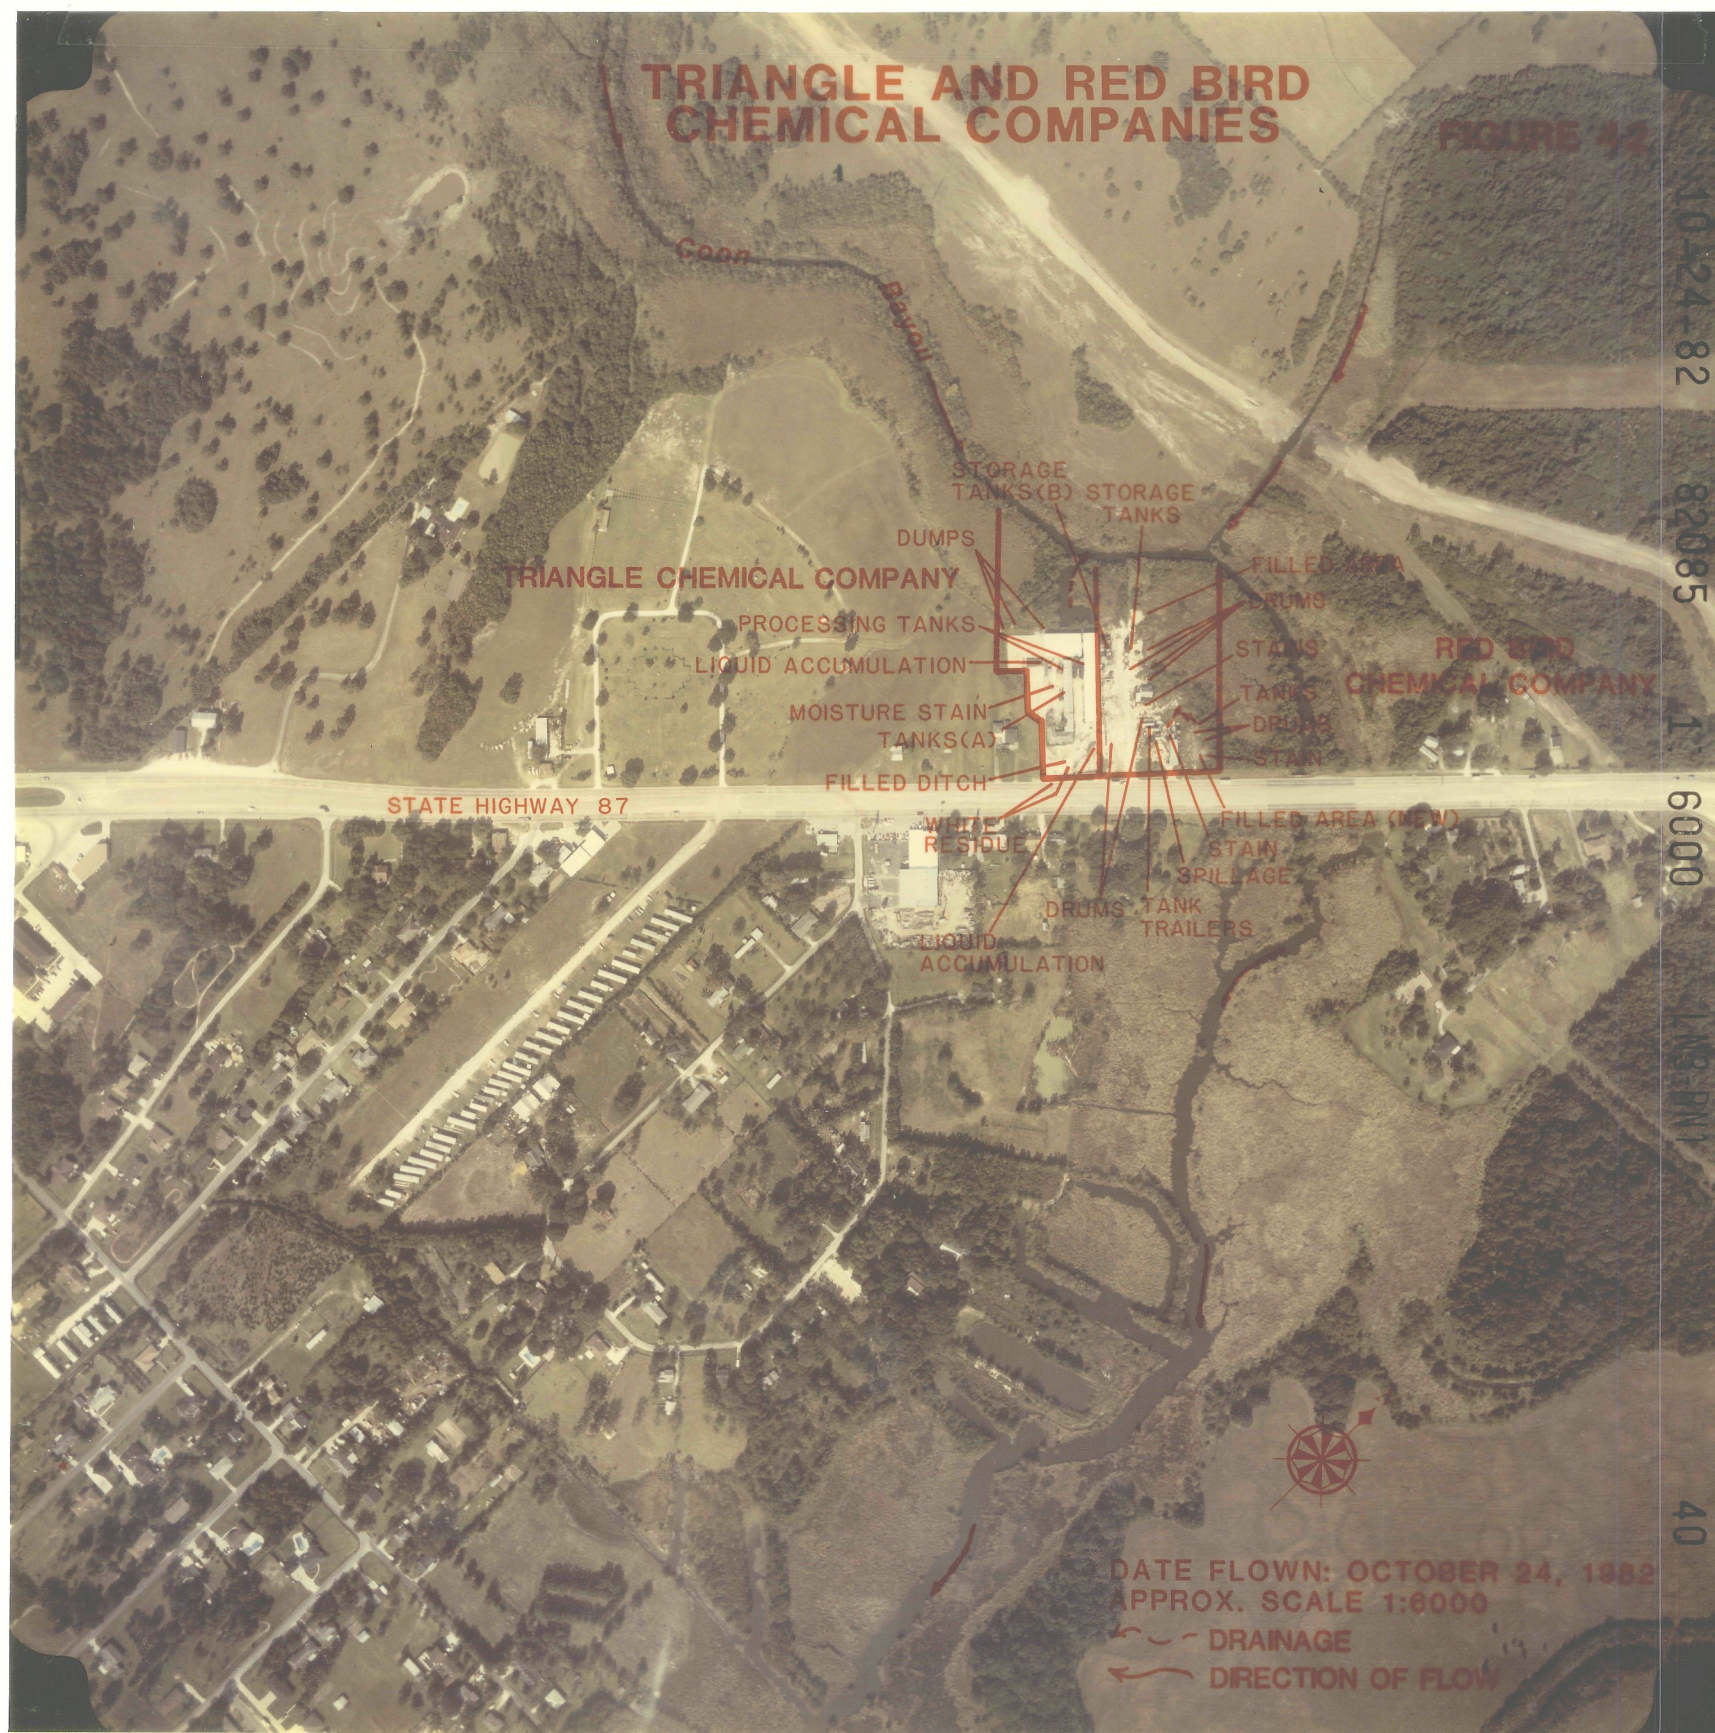
Tanks and dumps which were present on the August 1982 photograph remain intact. Those located within the Triangle Chemical facility (A) are contained by site structures. A second set of tanks (B) located within the Red Bird Chemical facility are enclosed by what appears to be a containment dike. Spillage does not appear to be a threat to Coon Bayou. A small dump that was not present on the earlier photograph has been situated between two dumps that were previously noted on the northwestern edge of the Triangle facility.

There has been no apparent cleanup conducted within the Red Bird Chemical facility. Waste liquid and spillage continues to drain into the area noted on the August 1982 photograph. Areas which have been filled are evident within the site. Stains are visible within the fill material.

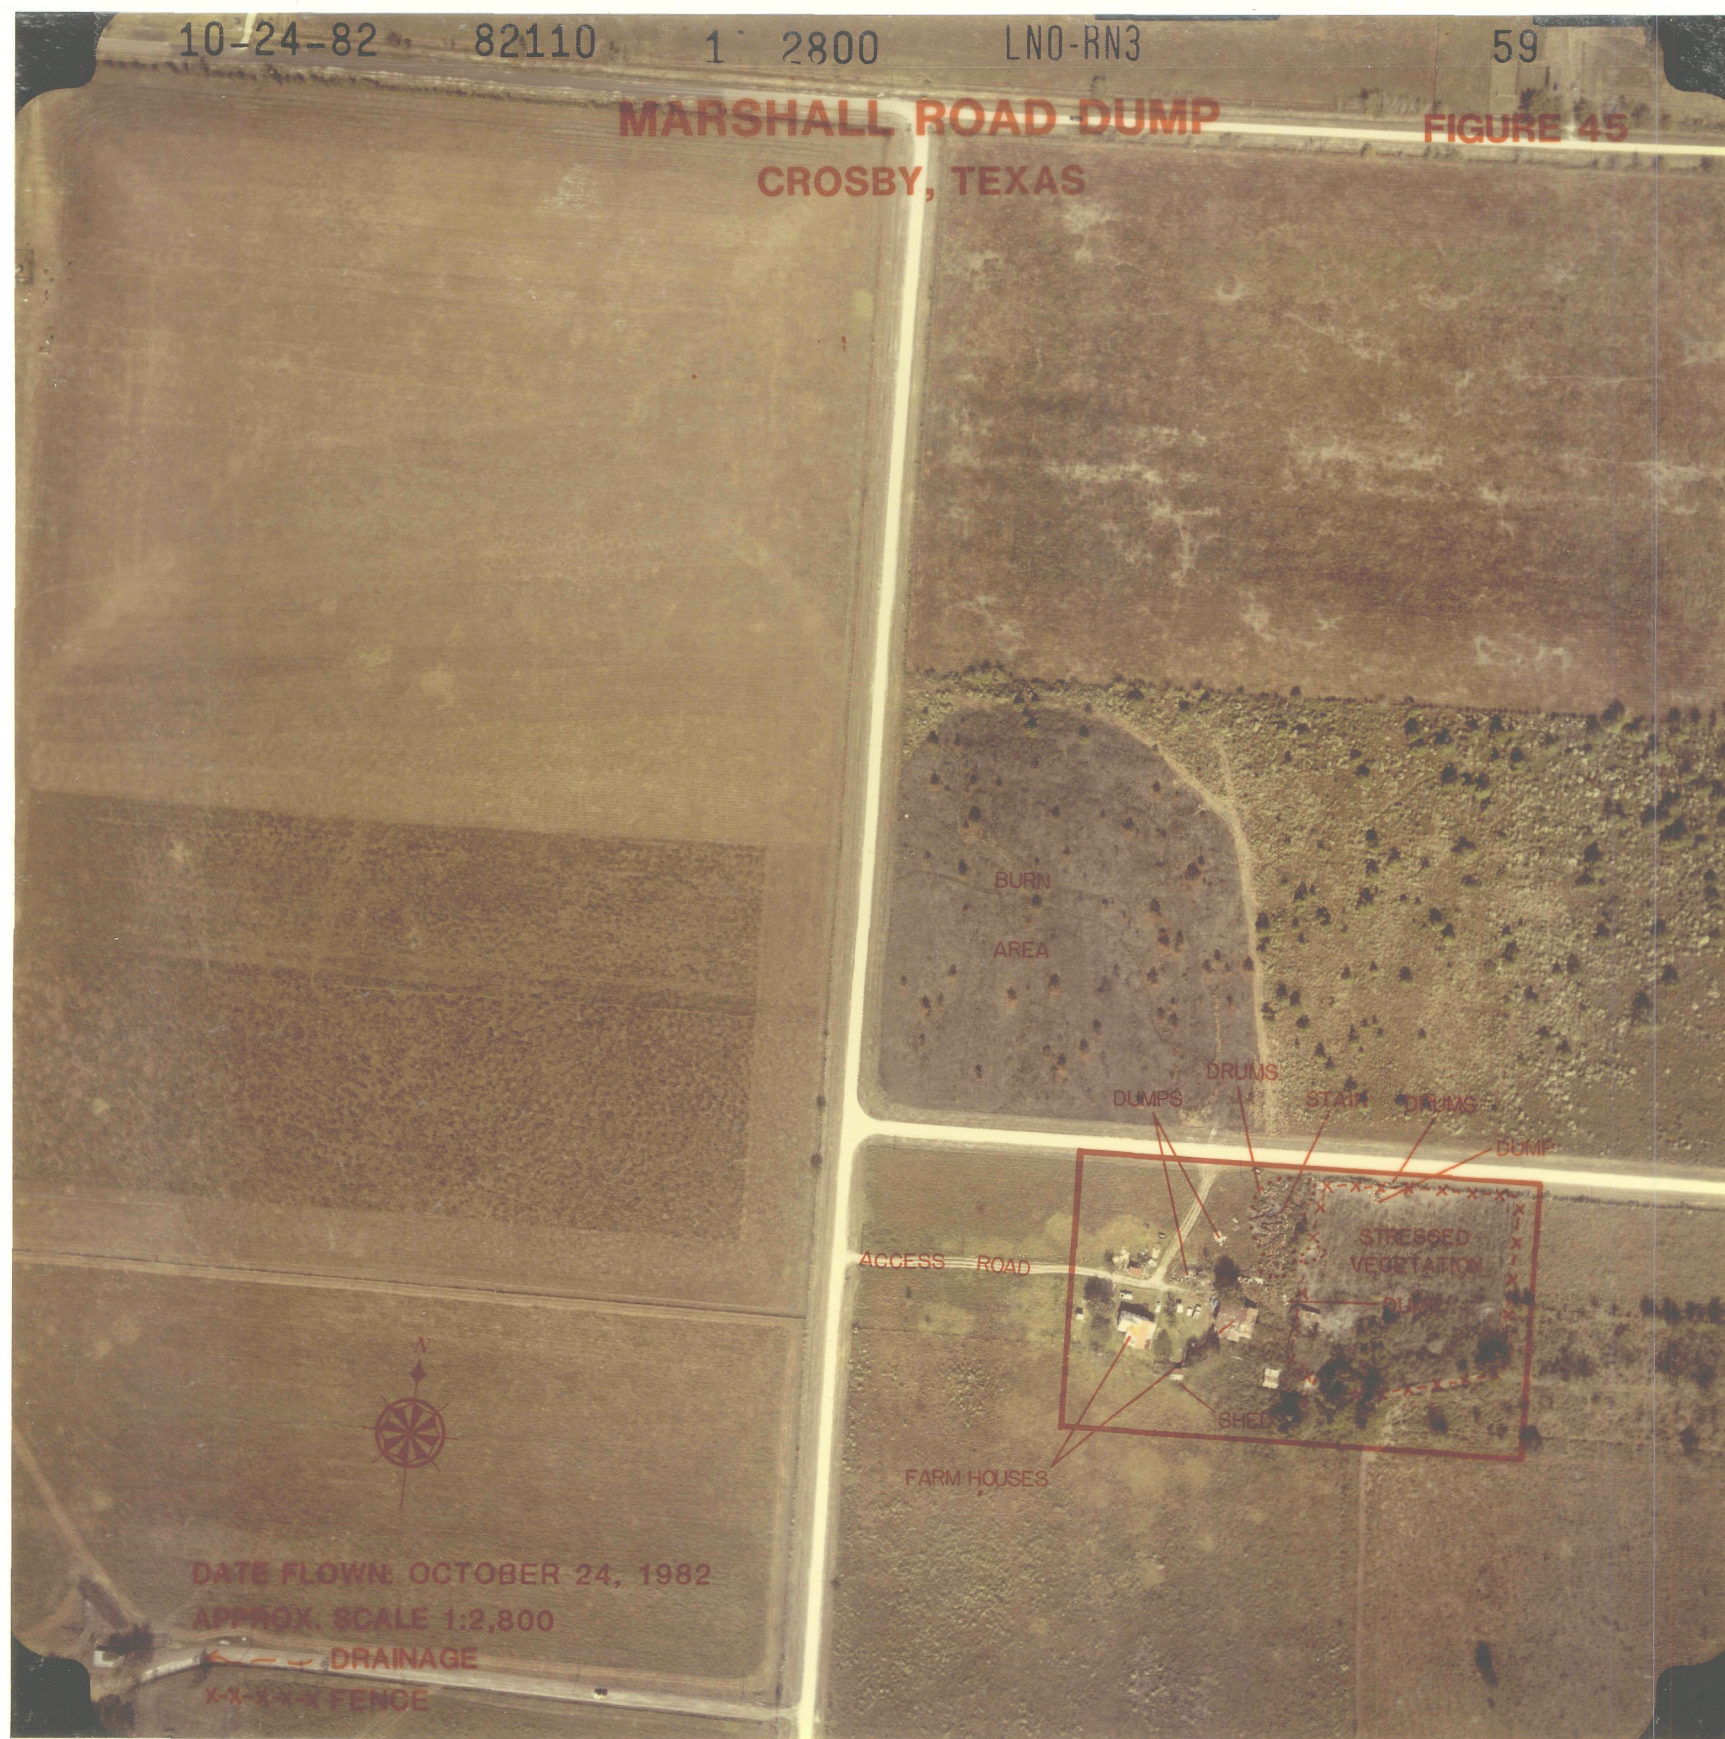
FIGURE 45

This dump (Figure 44) is located within a rural area approximately 5 kilometers (3 miles) east of Crosby, Texas. Approximately 350 drums have been discarded within the site (Figure 45). These appear to be the same drums that were present on May 10, 1982 (Figure 7, TS-AMD-82028b, June 1982). A large stain visible amid the concentration of drums may be the result of product that has spilled out of the drums.

A large burn area is noted northwest of the Marshall Road Dump. No evidence of burning was apparent on the May 10, 1982, photograph.

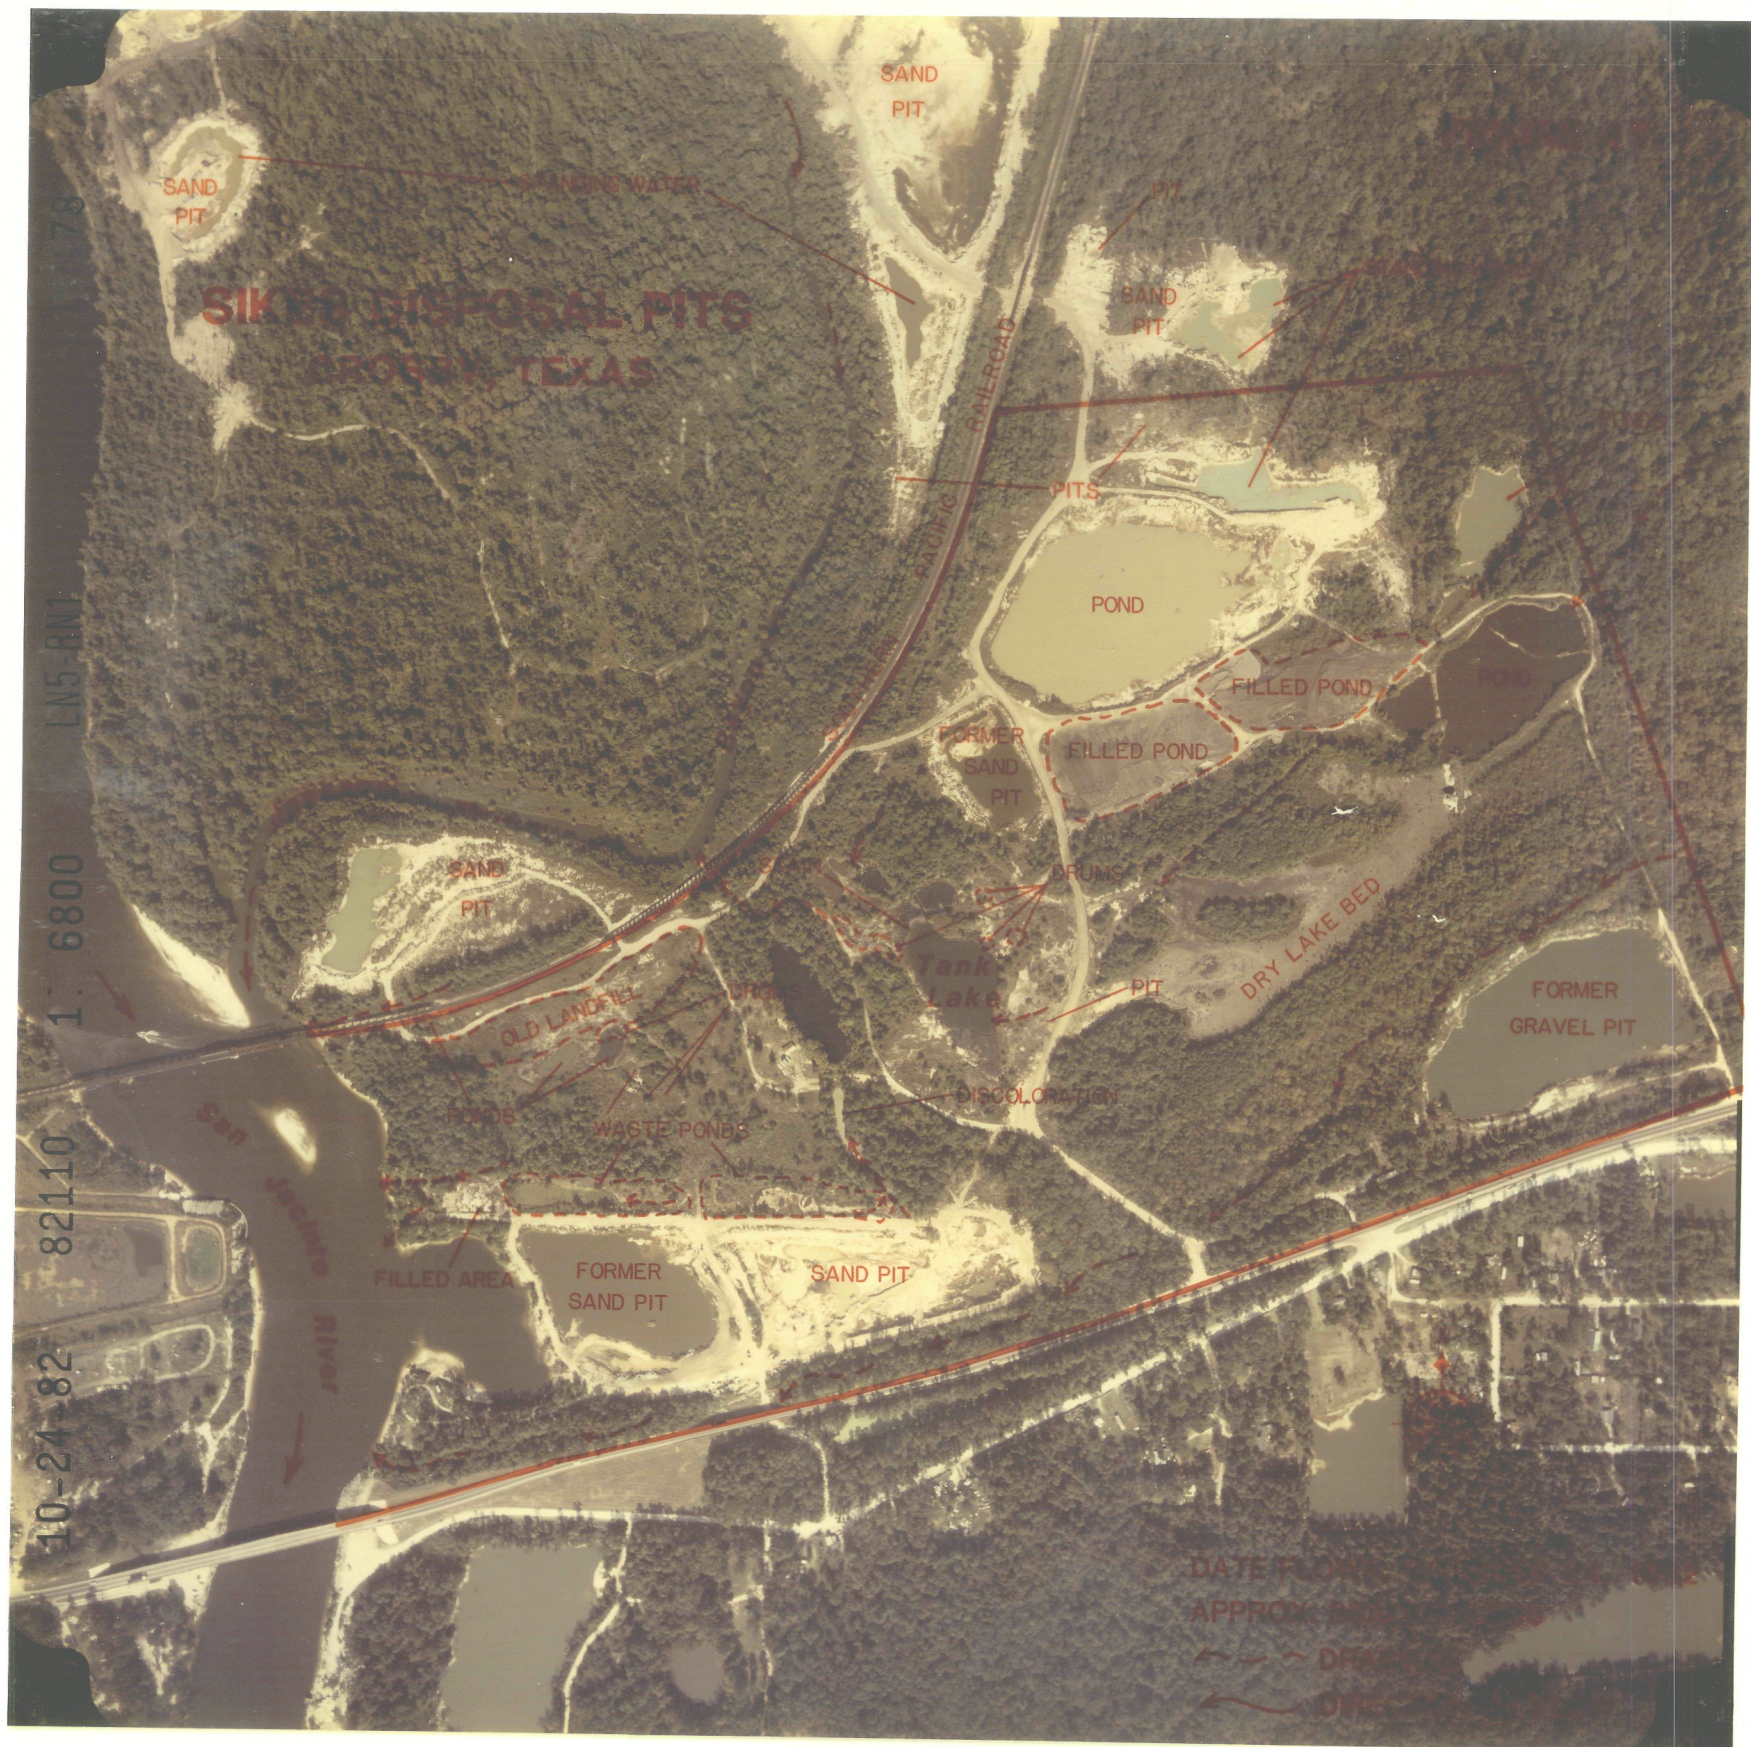
An estimated 100-250 drums are visible at seven locations within the site (Figure 47). An exact count of the drums is made difficult by the manner in which the drums are strewn together. Many of the drums within the largest concentration northwest of Tank Lake are obscured by either soil or underbrush. A highly stained area noted in this vicinity may have originated from drum spillage.

Several small pits are visible within spoil areas that abut the sand-dredged excavations. All were empty at the time that this photograph was collected. Two ponds which were present in the northern section of the site on April 14, 1980 (TS-AMD-8092, September 1980), have been filled. Filling has also occurred within a small area that is located near the San Jacinto River. Two old waste disposal ponds are visible in the same vicinity. Discoloration is noted within a drainage area which abuts the easternmost waste pond. The discoloration may be the result of runoff from the waste pond.

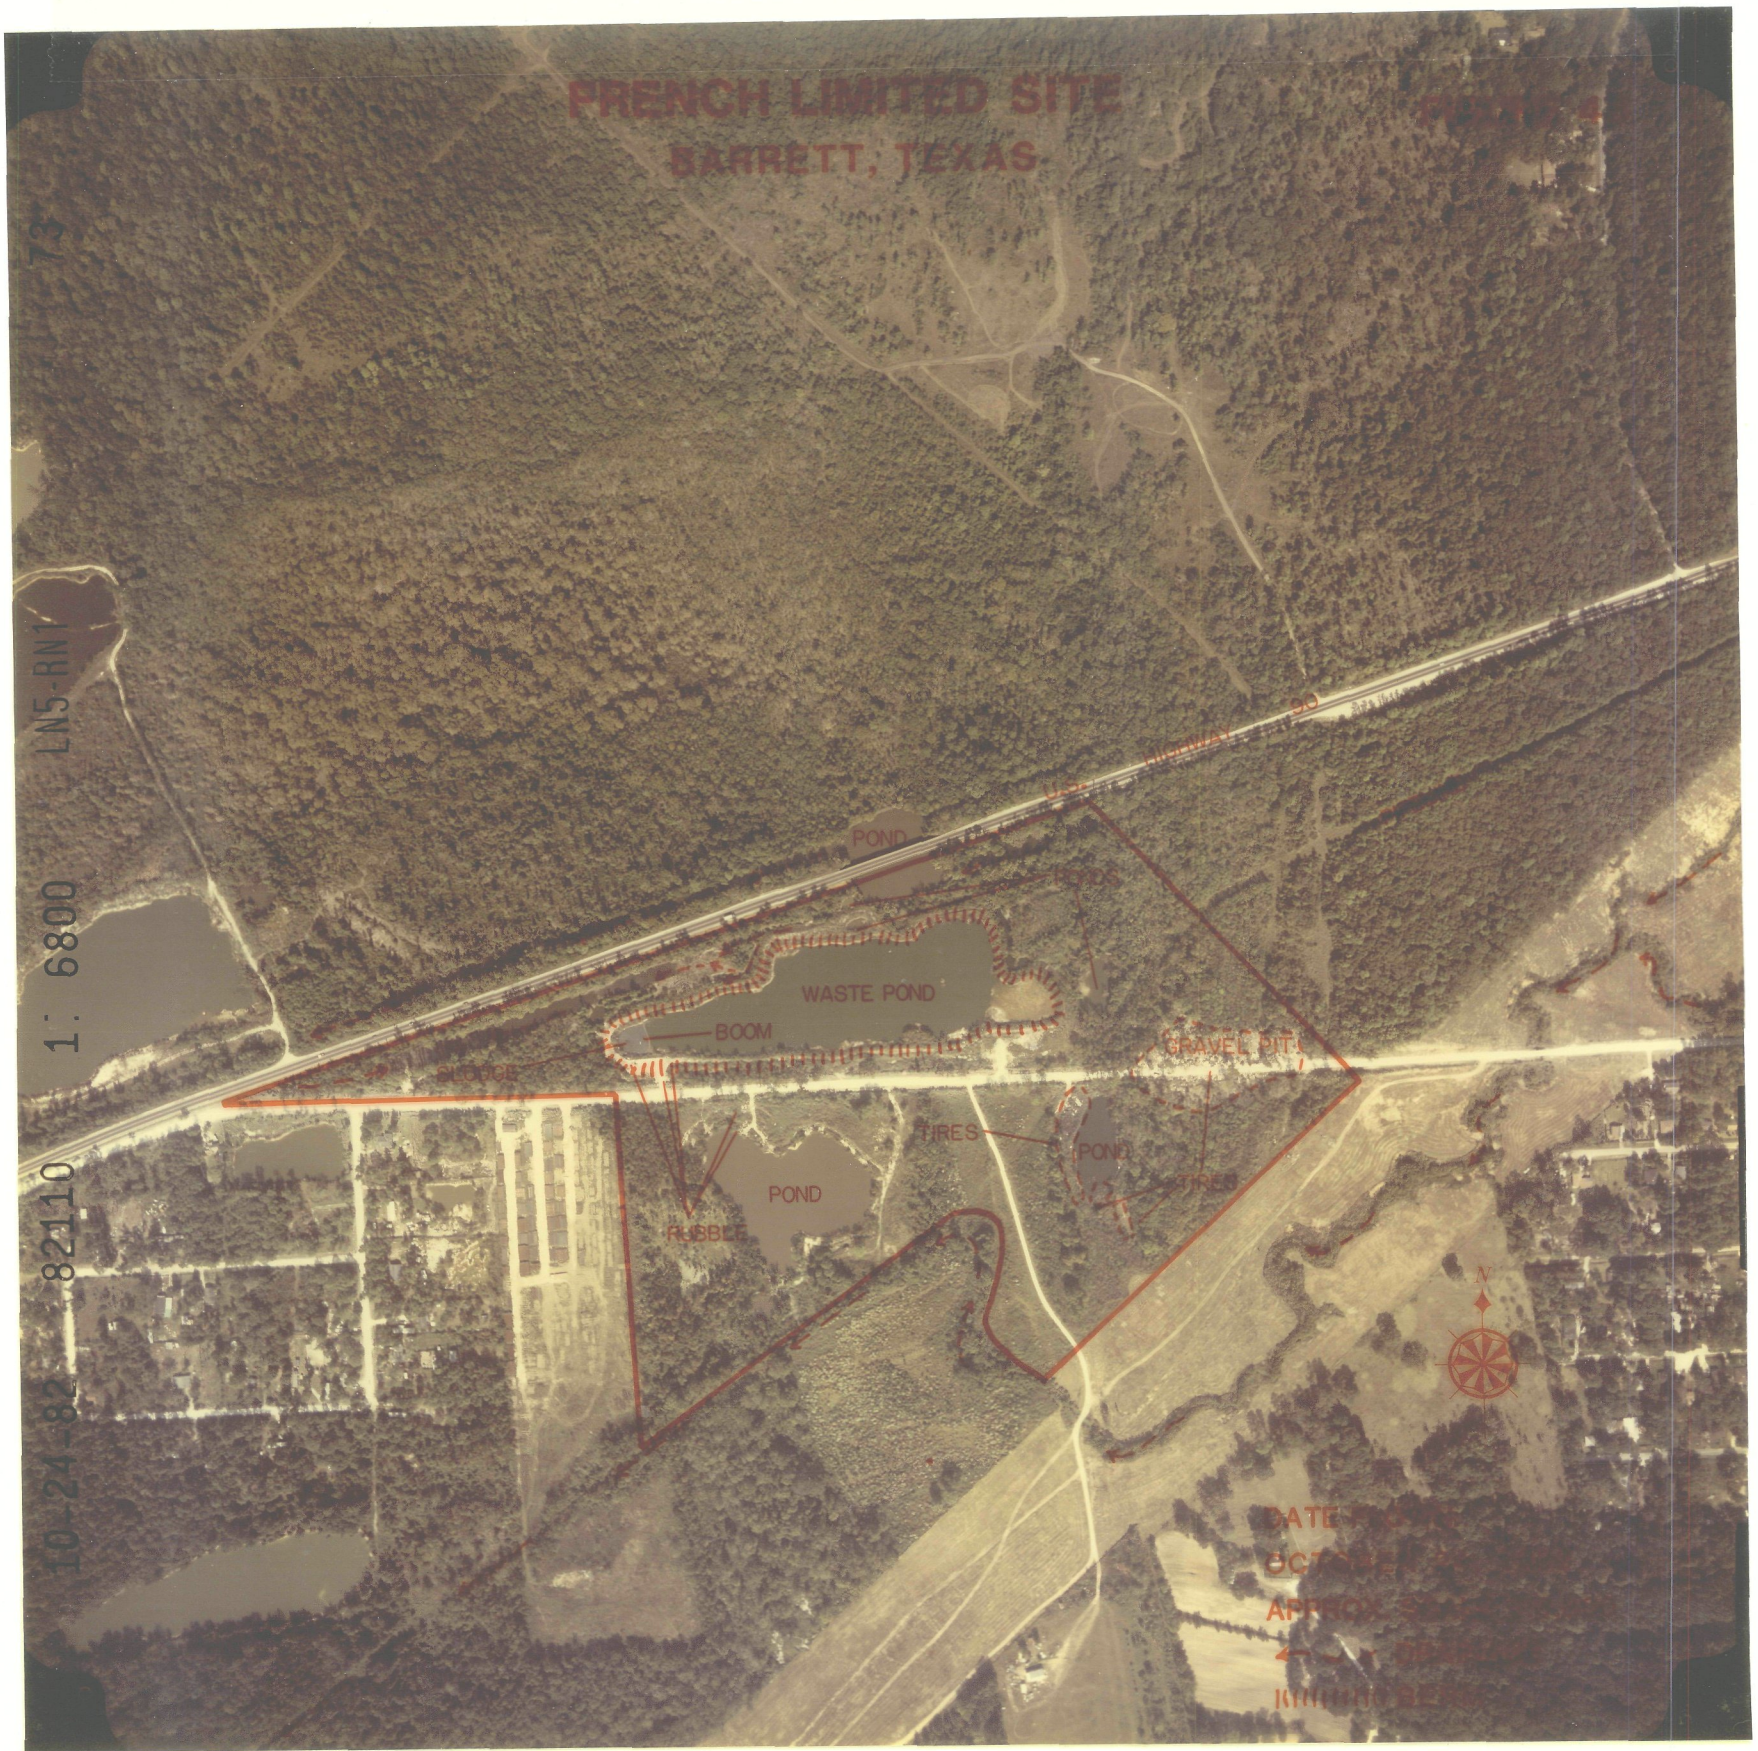
This site is a waste disposal area (Figure 46) that is located approximately 900 meters (3,000 feet) west-northwest of Barrett, Texas. Liquid wastes are most likely disposed of within a large waste pond which is surrounded by an earthen containment berm (Figure 48). The berm appears to be intact, and no seepages are noted. Sludge deposits are visible at the western end of the waste pond and are separated from the main liquid waste disposal area by a containment boom.

Solid wastes consist of rubble and old tires which have been dumped along the southern wall of the waste pond and within an old gravel pit. Debris and tires are also noted adjacent to, and within, several ponds which are present at the site. A rise in the water level within the ponds would most likely transport solid wastes into the accumulations of surface water.

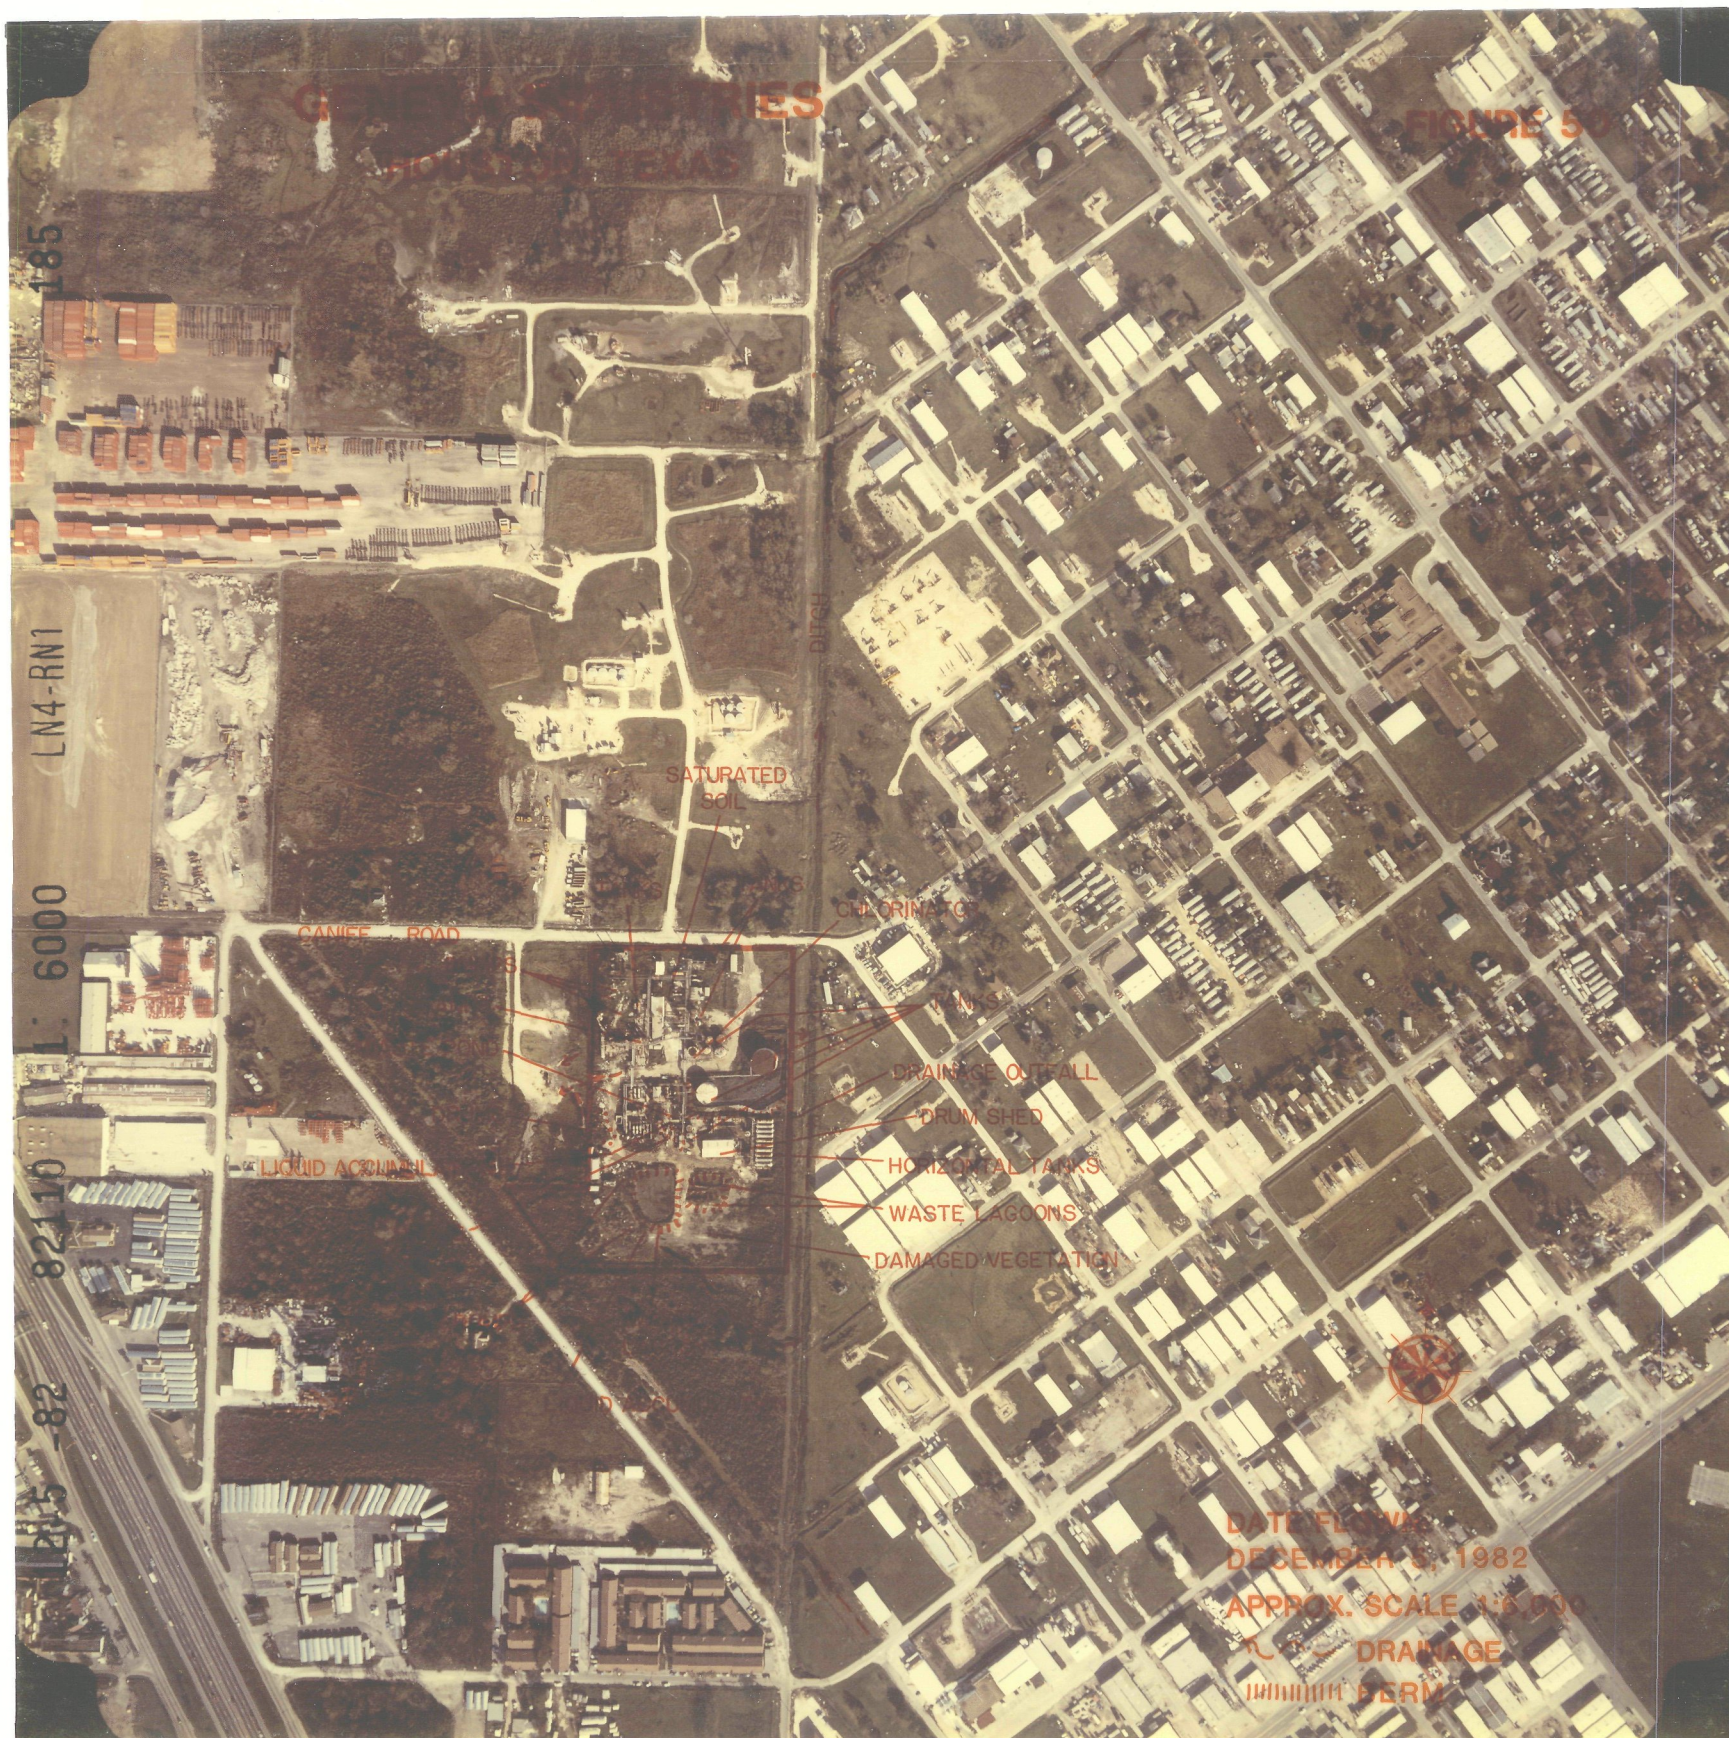
Few changes have occurred within the facility subsequent to May 10, 1982 (Figure 16, TS-AMD-82028b, June 1982). Accumulations of liquid noted near a waste lagoon and a small waste pond may be seepage or leachate from the waste disposal receptacles. An area located near the northern boundary of the site appears to be stained and saturated from several uncontained tanks that are present in that area. Although only two tanks within the facility appear contained, no spillage is visible within site drainages at this time. Concentrations of drums are present in approximately the same locations in which they were seen on the May 10, 1982, photograph.

Solid waste dumps are again visible in the southern half of the site. Additional dumps are present in the northwest corner of the facility in an area in which they were not previously noted. An area in which the vegetation has been severely damaged is visible in the southeast corner of the site.
